**Flood Control Project Maintenance  
Levee Inspections**  
**LMA District Cover Sheet**  
**Spring 2010 Levee Inspection Results**

**Reclamation District No. 1500 Sutter Basin**

**Levee Inspection Report By Mile - Spring 2010**

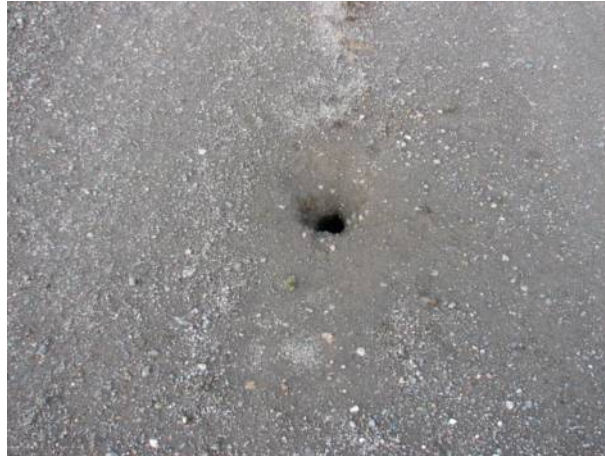
johngw\_s\_20100420\_116.jpg

hole in crown

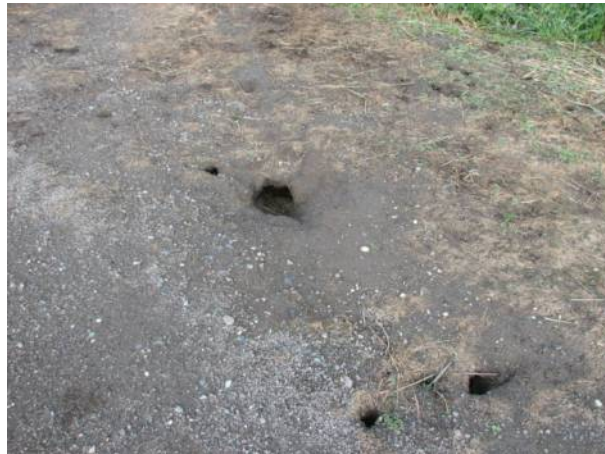
johngw\_s\_20100420\_117.jpg

| Waterway | | | | | | Bank | Unit Miles | Inspection Start/End | Inspector | |
|---|---|---|---|---|---|---|--|---|---|---|
| 5 | 0.06 | 0.06 | Earthen Levee | Animal Control | LS | M | Exterminate rodents and backfill and compact or grout burrows. | 38.761027 °<br>-121.675705 ° | 38.761027 °<br>-121.675705 ° | 985<br>Y |

holes on shoulder

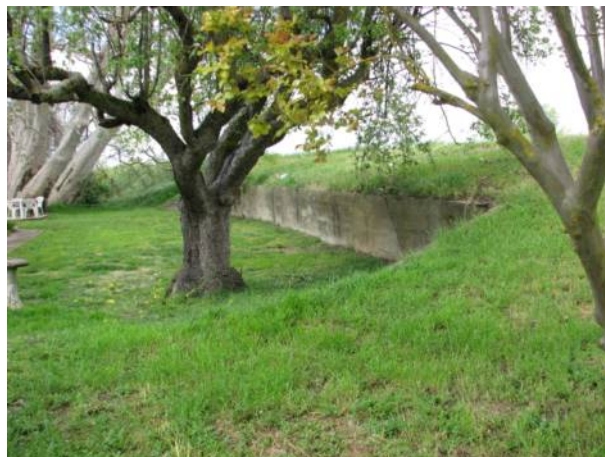
johngw\_s\_20100420\_118.jpg

| Waterway | | | | | | Bank | Unit Miles | Inspection Start/End | Inspector | |
|---|---|---|---|---|---|---|--|---|---|---|
| 11 | 1.34 | 1.34 | Earthen Levee | Encroachments | LS | PO | Landscaping<br>Inspector Comments: retaining wall into levee | 38.769983 °<br>-121.690610 ° | 38.769983 °<br>-121.690610 ° | 4<br>Y |

landscape and retaining wall

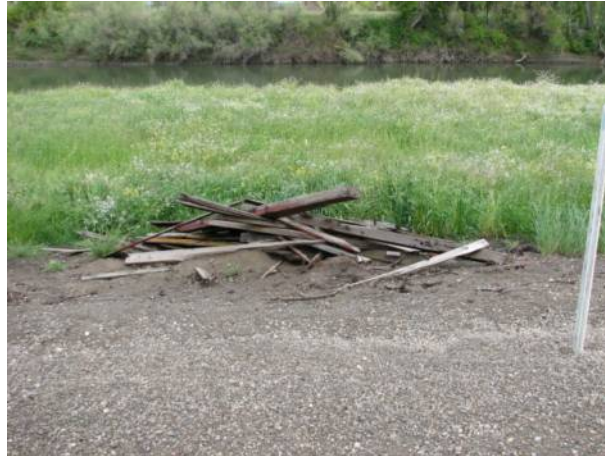
johnngw\_s\_20100420\_119.jpg

wood debris

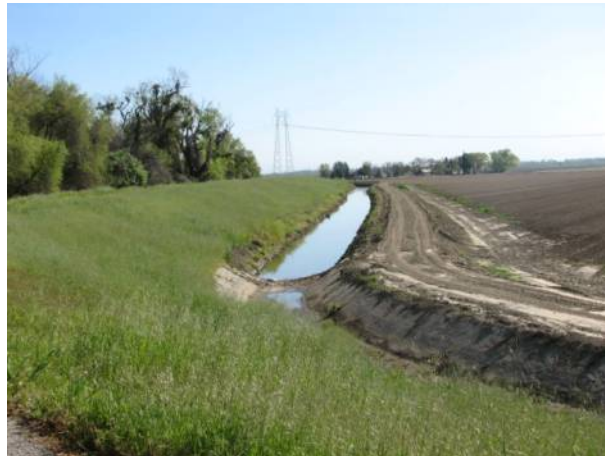
johnngw\_s\_20100316\_030.jpg

| Waterway | | | | | | Bank | Unit Miles | Inspection Start/End | Inspector | |
|---|---|---|---|---|---|---|--|---|---|---|
| 13 | 2.57 | 3.83 | Earthen Levee | Encroachments | LS | PO | Agricultural Ditch | 38.785351 °<br>-121.689075 ° | 38.797174 °<br>-121.693045 ° | 963<br>Y |

ag. ditch

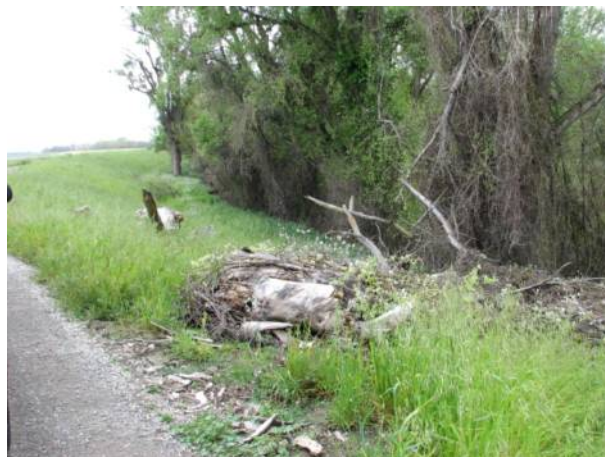
johnngw\_s\_20100420\_120.jpg

| Waterway | | | | | | Bank | Unit Miles | Inspection Start/End | Inspector | |
|---|---|---|---|---|---|---|--|---|---|---|
| 14 | 2.95 | 2.95 | Earthen Levee | Vegetation | WS | M | Remove the wild growth other than native grasses from the levee slopes.<br>Inspector Comments: tree fell has been cut to clear crown need to finish cutting up and clear vegetation on slope | 38.789107 °<br>-121.684616 ° | 38.789107 °<br>-121.684616 ° | 988<br>Y |

fallen tree waterside slope

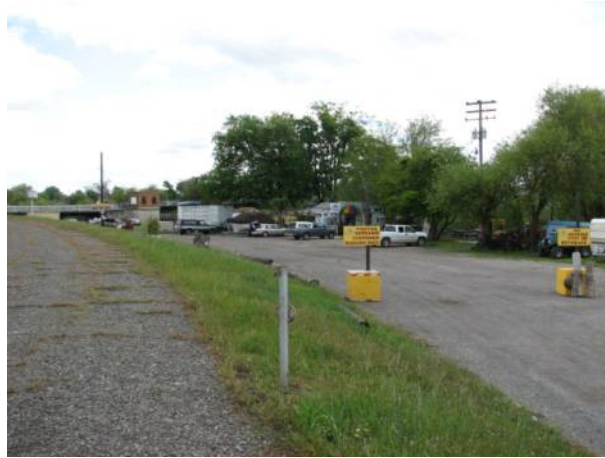
johngw\_s\_20100420\_121.jpg

Sting Rays Marina RV park

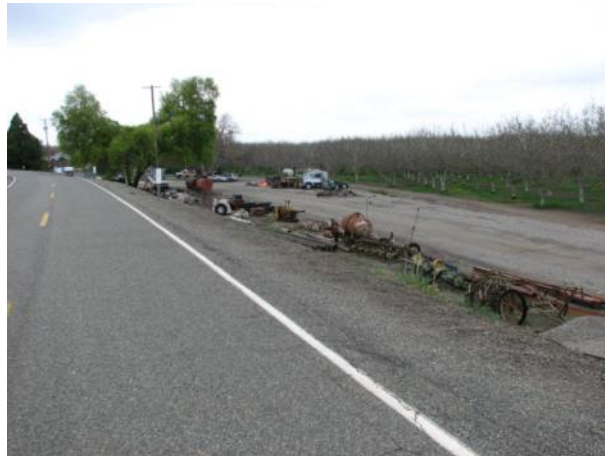
johngw\_s\_20100420\_122.jpg

| Waterway | | | | | | | Bank | Unit Miles | Inspection Start/End | Inspector |
|---|---|---|---|---|---|---|---|---|---|---|
| 25 | 7.57 | 7.57 | Earthen Levee | Encroachments | LS | M | Equipment | 38.828975 °<br>-121.724265 ° | 38.828975 °<br>-121.724265 ° | 16<br>Y |

along landside toe

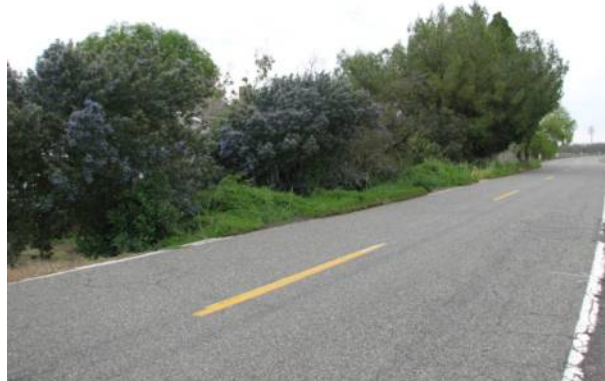
johngw\_s\_20100420\_123.jpg

| Waterway | | | | | | | Bank | Unit Miles | Inspection Start/End | Inspector |
|---|---|---|---|---|---|---|---|---|---|---|
| 26 | 7.68 | 7.68 | Earthen Levee | Encroachments | LS | PO | Landscaping | 38.830200 °<br>-121.725268 ° | 38.830200 °<br>-121.725268 ° | 17<br>Y |

landscape shrubs

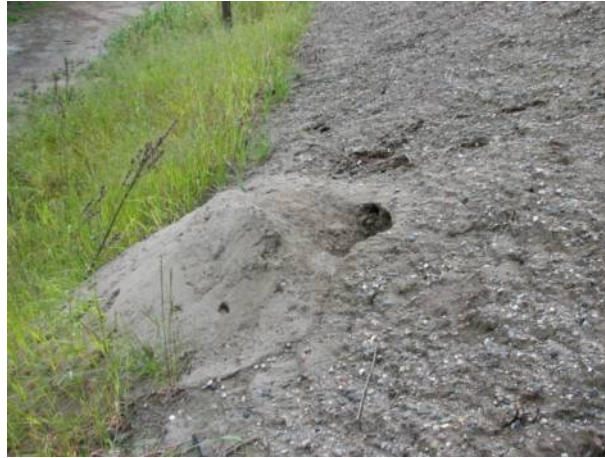
johngw\_s\_20100420\_124.jpg

large amount of spoils landside

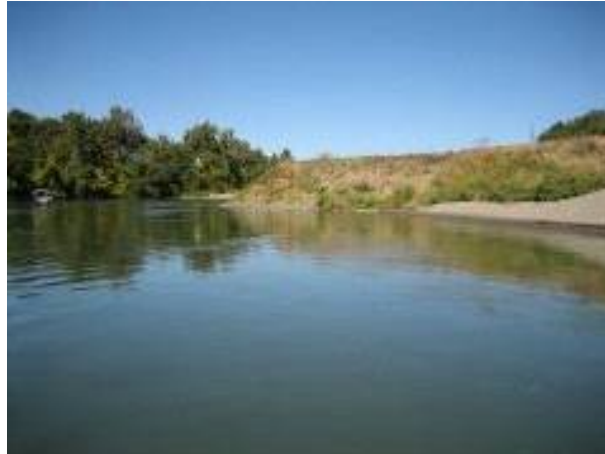
USACE2009\_SAC\_92-8\_L\_2009\_09\_16-D2P47\_small.JPG

| Waterway | | | | | | | Bank | Unit Miles | Inspection Start/End | Inspector |
|---|---|---|---|---|---|---|---|---|---|---|
| 30 | 8.33 | 8.54 | Supplemental | USACE Erosion Survey | WS | U | Inspector Comments: 2009: no berm, 2:1 slope, slumping, sands and silts, 3.32 ft/s [2009 SiteID:SAC_92-8_L] | 38.840417 °<br>-121.726864 ° | 38.838428 °<br>-121.730253 ° | 40<br>Y |

2009: no berm, 2:1 slope, slumping, sands and silts, 3.32 ft/s [2009 SiteID:SAC\_92-8\_L]

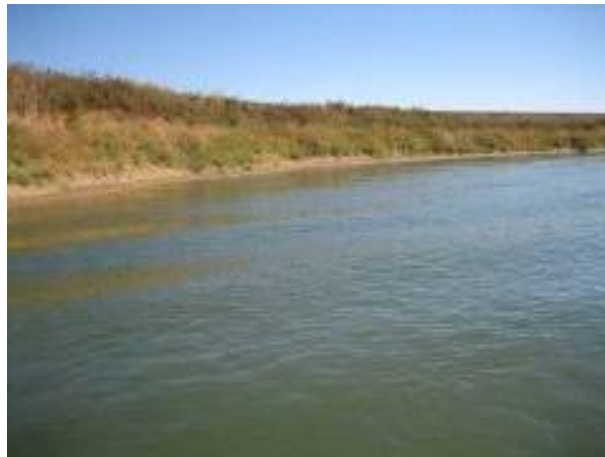
USACE2009\_SAC\_93-7\_L\_2009\_09\_16-D2P46\_small.JPG

| Waterway | | | | | | | Bank | Unit Miles | Inspection Start/End | Inspector |
|---|---|---|---|---|---|---|---|---|---|---|
| 32 | 9.44 | 9.65 | Supplemental | USACE Erosion Survey | WS | M | Inspector Comments: 2009: 15 ft berm, 1.5:1 slope, no stability issues, clays and silts, 3.37 ft/s [2009 SiteID:SAC_93-7_L] | 38.852361 °<br>-121.723619 ° | 38.850272 °<br>-121.723922 ° | 41<br>Y |

2009: 15 ft berm, 1.5:1 slope, no stability issues, clays and silts, 3.37 ft/s [2009 SiteID:SAC\_93-7\_L]

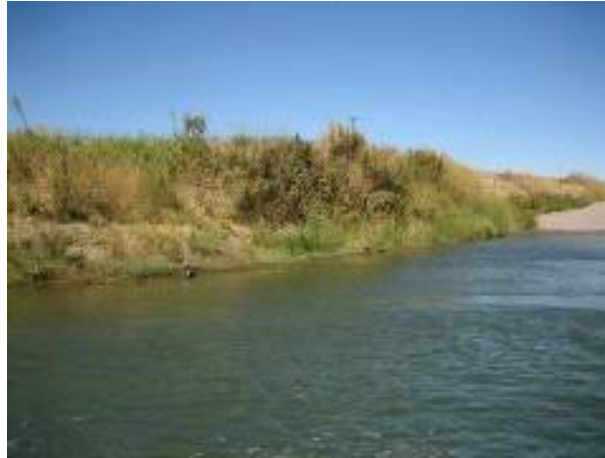
| USACE2009_SAC_96-2_L_2009_09_16-D2P39_small.JPG | |

| Waterway | | | | | | | Bank | Unit Miles | Inspection Start/End | Inspector |
|---|---|---|---|---|---|---|--|---|---|---|
| 35 | 12.10 | 12.38 | Supplemental | USACE Erosion Survey | WS | M | Inspector Comments: 2009: 15 ft berm, 1.5:1 slope, holes and slumping, clays and silts, 3.22 ft/s [2009 SiteID:SAC_96-2_L] | 38.869139 °<br>-121.757108 ° | 38.870475 °<br>-121.752236 ° | 43<br>Y |

| 2009: 15 ft berm, 1.5:1 slope, holes and slumping, clays and silts, 3.22 ft/s [2009 SiteID:SAC_96-2_L] | |

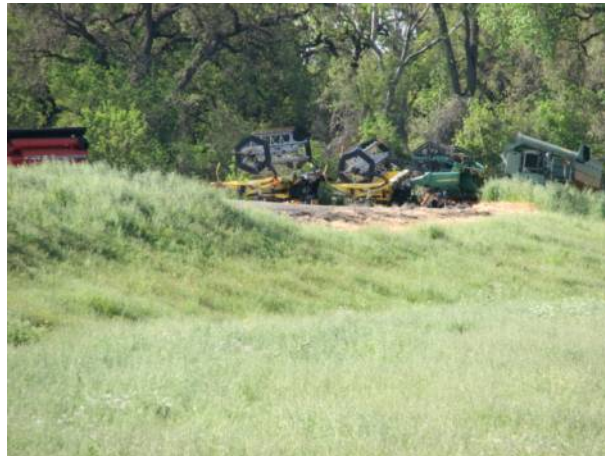
| johngw_s_20100420_127.jpg | |

| Waterway | | | | | | | Bank | Unit Miles | Inspection Start/End | Inspector |
|---|---|---|---|---|---|---|--|---|---|---|
| 43 | 14.13 | 14.13 | Earthen Levee | Encroachments | WS | M | Equipment | 38.857792 °<br>-121.783265 ° | 38.857792 °<br>-121.783265 ° | 28<br>Y |

| shot of equipment | |

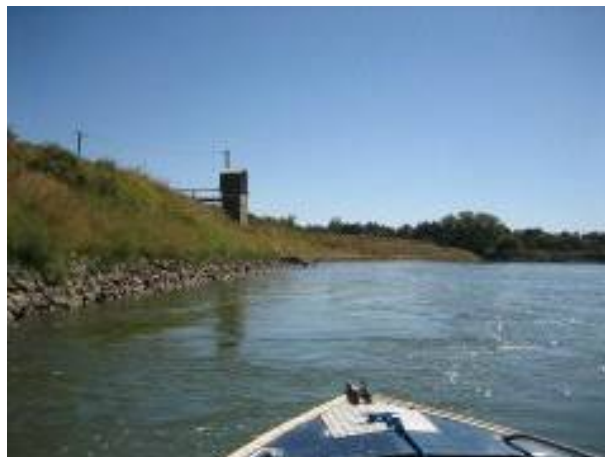
| USACE2009_SAC_99-0_L_2009_09_16-D2P37_small.JPG | |

| Waterway | | | | | | | Bank | Unit Miles | Inspection Start/End | Inspector |
|---|---|---|---|---|---|---|--|---|---|---|
| 44 | 14.13 | 14.43 | Supplemental | USACE Erosion Survey | WS | M | Inspector Comments: 2009: 10 ft berm, 1:1 slope, slumping, sands and silts, 2.72 ft/s [2009 SiteID:SAC_99-0_L] | 38.861889 °<br>-121.784083 ° | 38.857233 °<br>-121.783803 ° | 44<br>Y |

| 2009: 10 ft berm, 1:1 slope, slumping, sands and silts, 2.72 ft/s [2009 SiteID:SAC_99-0_L] | |

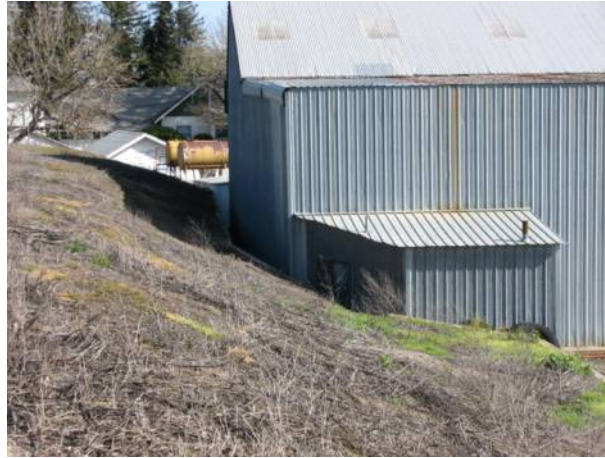
johngw\_s\_20100420\_128.jpg

| Waterway | | | | | | | Bank | Unit Miles | Inspection Start/End | Inspector |
|---|---|---|---|---|---|---|--|---|---|---|
| 45 | 14.35 | 14.35 | Earthen Levee | Encroachments | LS | CO | Buildings<br>Inspector Comments: concrete stemwall into levee embankment | 38.860848 °<br>-121.783307 ° | 38.860848 °<br>-121.783307 ° | 30<br>Y |

building and wall into levee

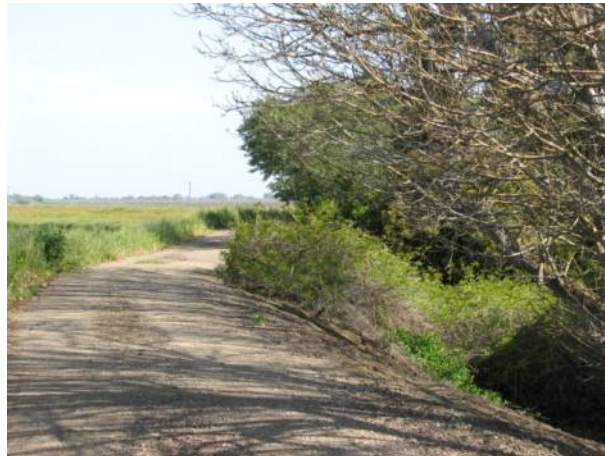
johngw\_s\_20100420\_129.jpg

| Waterway | | | | | | | Bank | Unit Miles | Inspection Start/End | Inspector |
|---|---|---|---|---|---|---|--|---|---|---|
| 46 | 14.39 | 14.39 | Earthen Levee | Encroachments | LS | CO | Landscaping | 38.861513 °<br>-121.783588 ° | 38.861513 °<br>-121.783588 ° | 31<br>Y |

landscape shrubs on shoulder

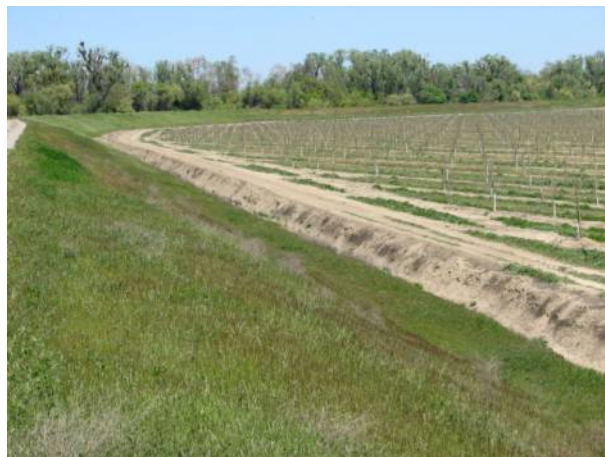
johngw\_s\_20100316\_031.jpg

| Waterway | | | | | | | Bank | Unit Miles | Inspection Start/End | Inspector |
|---|---|---|---|---|---|---|--|---|---|---|
| 48 | 14.86 | 15.93 | Earthen Levee | Encroachments | LS | PO | Agricultural Ditch | 38.865473 °<br>-121.789413 ° | 38.871752 °<br>-121.804257 ° | 969<br>Y |

ag. ditch

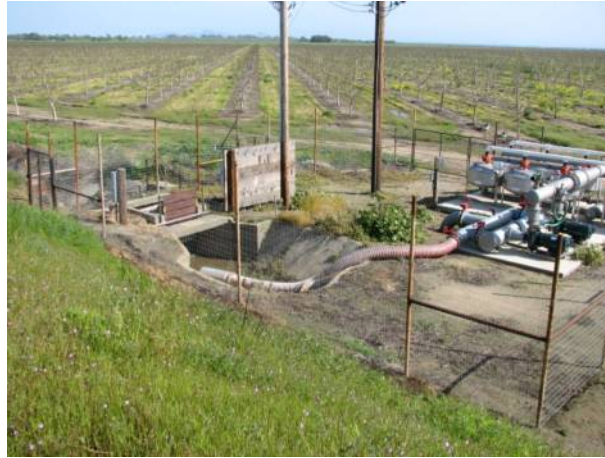
johnngw\_s\_20100420\_130.jpg

| Waterway | | | | | | | Bank | Unit Miles | Inspection Start/End | Inspector |
|---|---|---|---|---|---|---|--|---|---|---|
| 49 | 15.27 | 15.27 | Earthen Levee | Encroachments | LS | PO | Fences<br>Inspector Comments: fence compound around sand separators fence at toe | 38.866825 °<br>-121.794020 ° | 38.866825 °<br>-121.794020 ° | 22<br>Y |

fence into levee toe

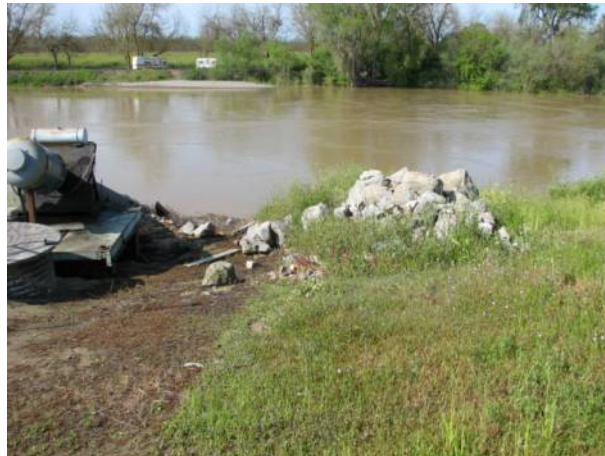
johnngw\_s\_20100420\_131.jpg

| Waterway | | | | | | Bank | Unit Miles | Inspection Start/End | Inspector | |
|---|---|---|---|---|---|---|--|---|---|---|
| 50 | 15.27 | 15.27 | Earthen Levee | Encroachments | WS | M | Debris<br>Inspector Comments: pile of rip rap and concrete needs to be placed | 38.866827 °<br>-121.794020 ° | 38.866827 °<br>-121.794020 ° | 21<br>Y |

rip rap and concrete debris

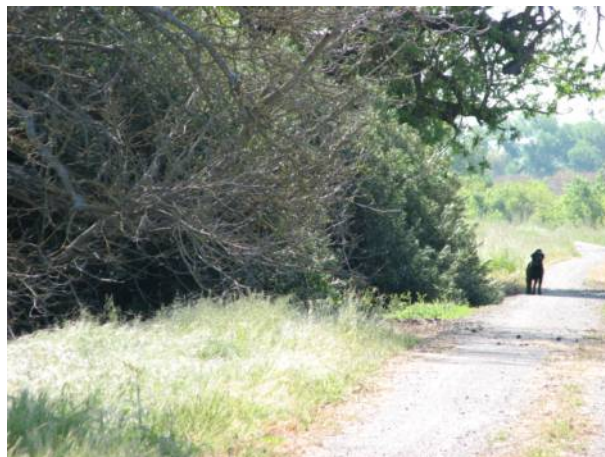
johnngw\_s\_20100420\_132.jpg

| Waterway | | | | | | Bank | Unit Miles | Inspection Start/End | Inspector | |
|---|---|---|---|---|---|---|--|---|---|---|
| 52 | 16.47 | 16.47 | Earthen Levee | Encroachments | LS | CO | Landscaping<br>Inspector Comments: oleanders and other shrubs | 38.875788 °<br>-121.812268 ° | 38.875788 °<br>-121.812268 ° | 33<br>Y |

landscape shrubs

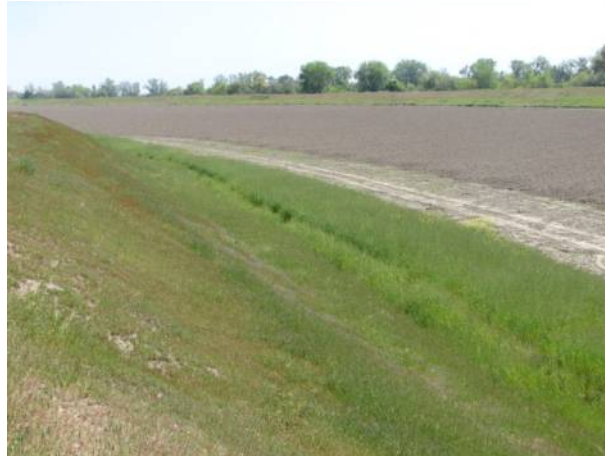
| johngw_s_20100316_032.jpg | |

| ag. ditch | |

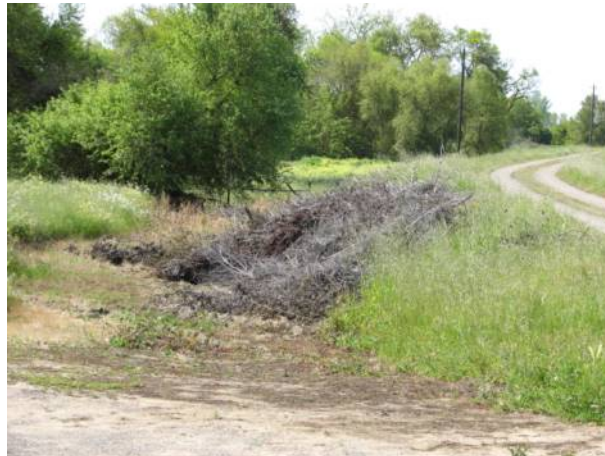
| johngw_s_20100420_133.jpg | |

| Waterway | | | | | | Bank | Unit Miles | Inspection Start/End | Inspector | |
|---|---|---|---|---|---|---|--|---|---|---|
| 54 | 17.83 | 17.83 | Earthen Levee | Encroachments | LS | M | Prunings | 38.891944 °<br>-121.804794 ° | 38.891944 °<br>-121.804794 ° | 994<br>Y |

| prunings | |

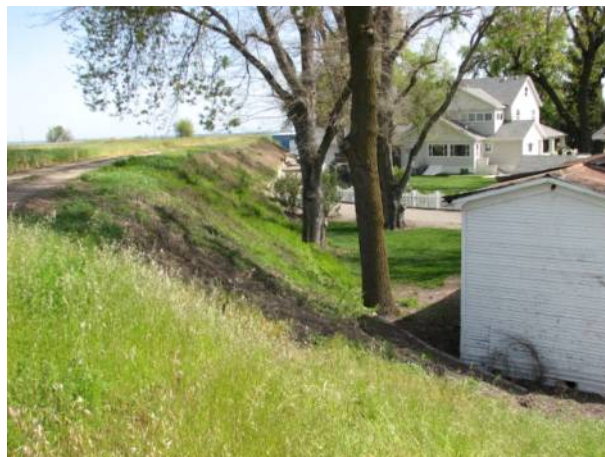
| johngw_s_20100420_134.jpg | |

| Waterway | | | | | | Bank | Unit Miles | Inspection Start/End | Inspector | |
|---|---|---|---|---|---|---|--|---|---|---|
| 56 | 19.19 | 19.19 | Earthen Levee | Encroachments | LS | PO | Buildings<br>Inspector Comments: concrete retaining wall toe of landside levee permit #10065 | 38.901570 °<br>-121.791235 ° | 38.901570 °<br>-121.791235 ° | 36<br>Y |

| building and wall into levee with landscape | |

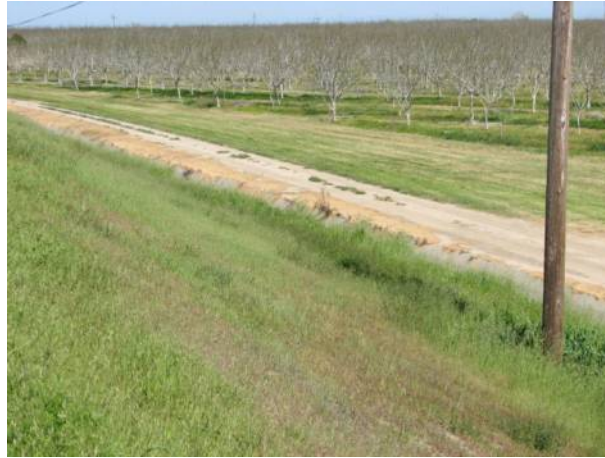
johnwgw\_s\_20100316\_033.jpg

ag. ditch

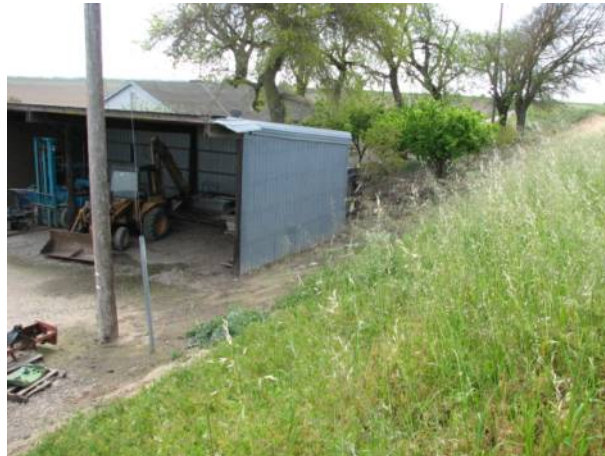
johnwgw\_s\_20100420\_135.jpg

pole barn and some equipment

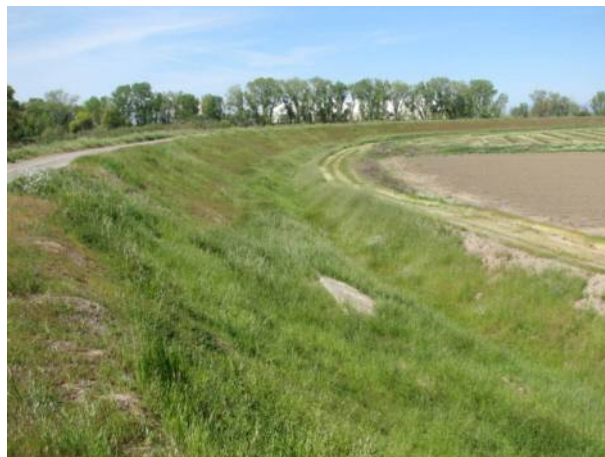
johnwgw\_s\_20100316\_034.jpg

| Waterway | | | | | | Bank | Unit Miles | Inspection Start/End | Inspector | |
|---|---|---|---|---|---|---|--|---|---|---|
| 62 | 24.44 | 24.78 | Earthen Levee | Encroachments | LS | PO | Agricultural Ditch | 38.936282 °<br>-121.830192 ° | 38.940712 °<br>-121.830650 ° | 979<br>Y |

ag. ditch

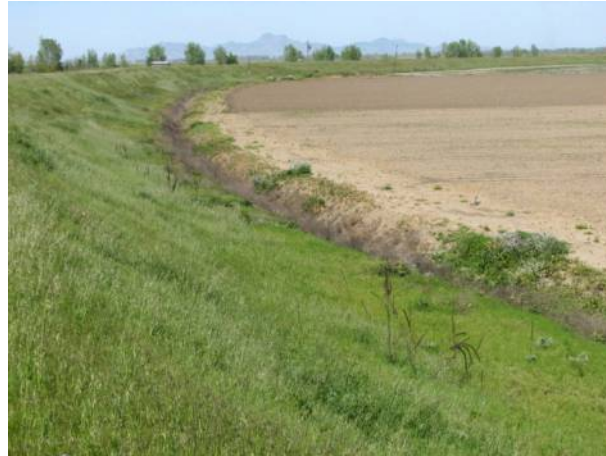
| johngw_s_20100316_035.jpg | |

| ag. ditch | |

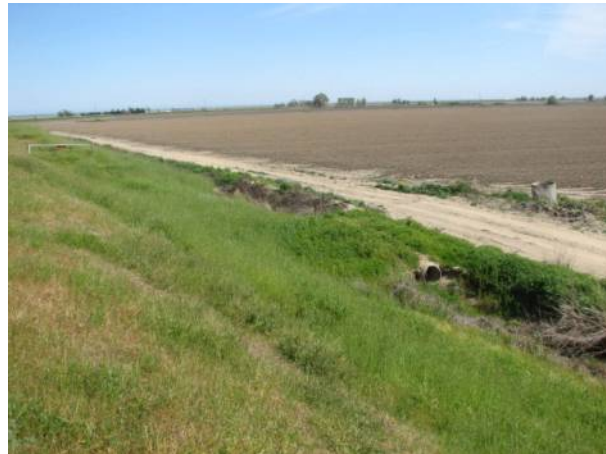
| johngw_s_20100316_036.jpg | |

| ag. ditch | |

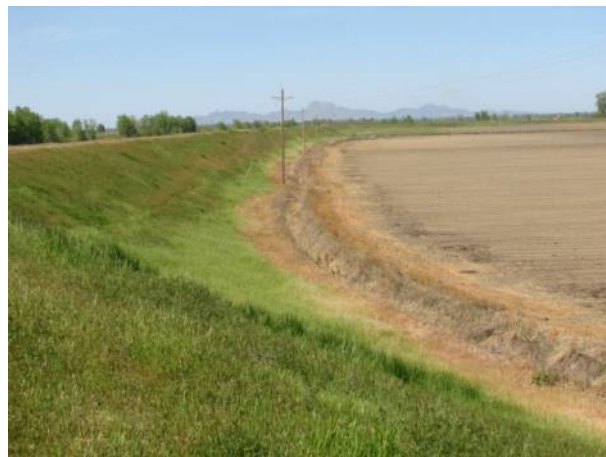
| johngw_s_20100316_037.jpg | |

| ag. ditch | |

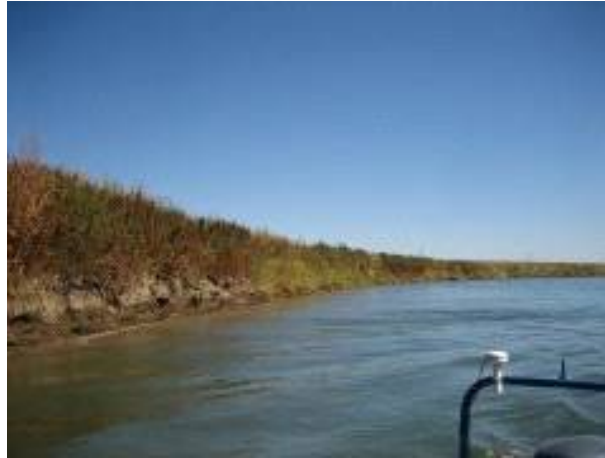
| 2009: 10 ft berm, 1.5:1 slope, holes and slumping, clays and silts, 4 ft/s [2009 SiteID:SAC_116-5_L]<br><br>USACE2009_SAC_116-5_L_2009_09_16-D2P23_small.JPG | |

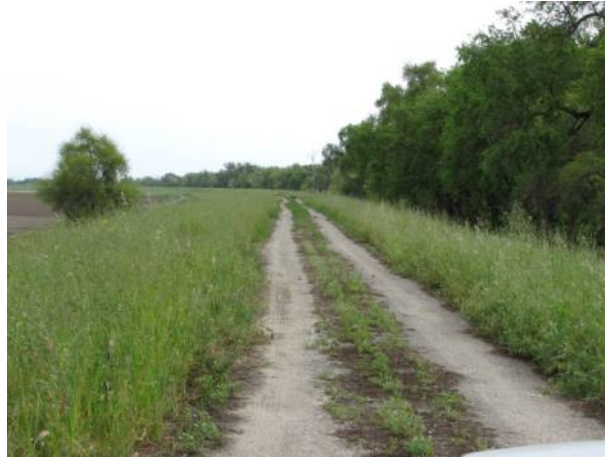
johnngw\_s\_20100420\_113.jpg

Grasses more than 12"

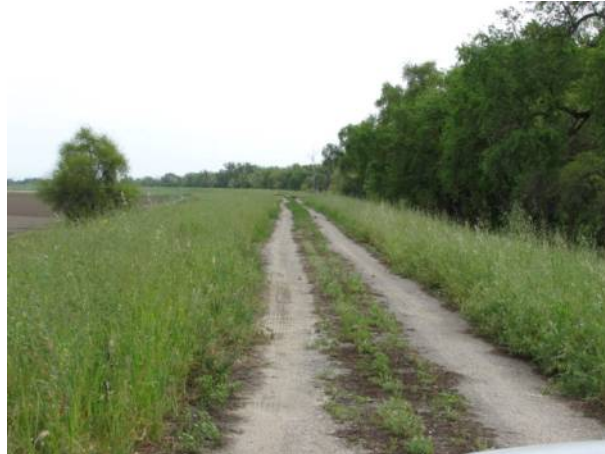
johnngw\_s\_20100420\_114.jpg

Grasses more than 12"

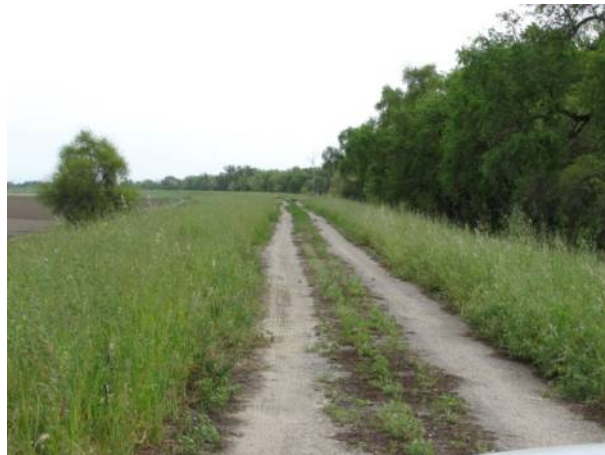
johnngw\_s\_20100420\_115.jpg

Vegetation on crown

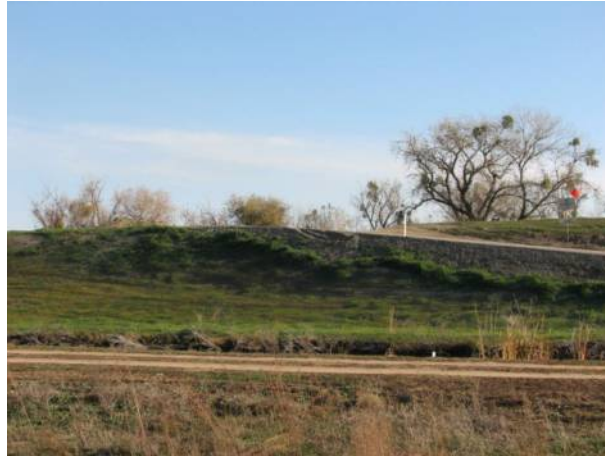
| johngw_s_20100316_038.jpg | |

| cross view of levee crown | |

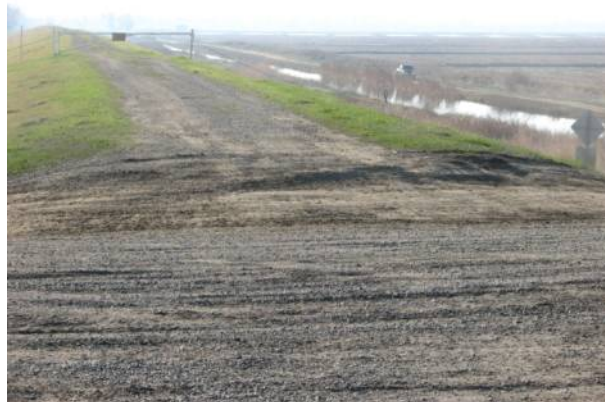
| johngw_s_20100316_039.jpg | |

| Waterway | | | | | | | Bank | Unit Miles | Inspection Start/End | Inspector |
|---|---|---|---|---|---|---|--|---|---|---|
| 11 | 11.03 | 11.03 | Earthen Levee | Crown Surface / Depressions / Rutting | CR | M | Add appropriate gravel or road base. Grade and compact.<br>Inspector Comments: This is a county (Kirkville Rd) that crosses the levee. The truck traffic and the county grading, the road has degraded the crown. Need to have AB material to reestablish the crown to proper grade.Some improvement has been made to crown of road. | 38.909385 °<br>-121.639435 ° | 38.909385 °<br>-121.639435 ° | 17<br>Y |

| dip coming off the crown of levee | |

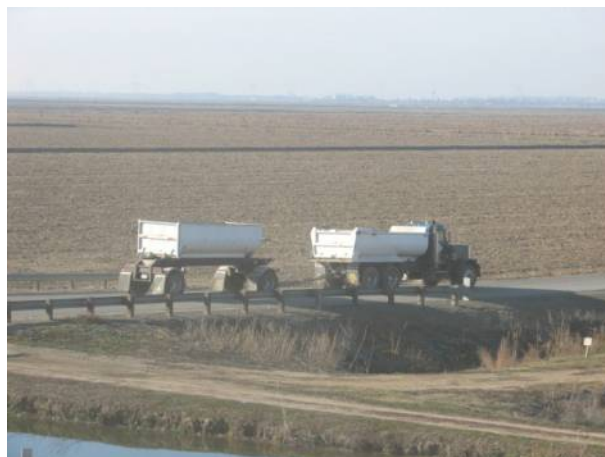
| johngw_s_20100316_040.jpg | |

| typical truck that crosses the levee | |
